Periodic Inspection Report No. 4
West River
Townshend, Vermont

Townshend Lake

October 1996

US Army Corps
of Engineers

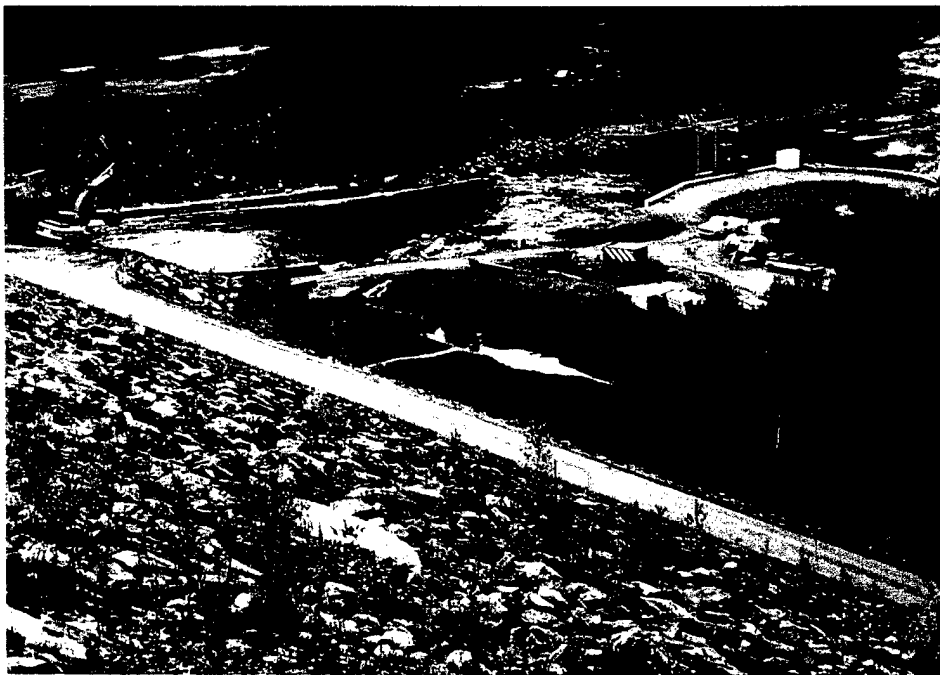
(4) Seepage. Townshend Dam has a history of seepage problems including piping and boils along the downstream toe. On the day of the inspection, flow of about 5 to 10 gpm was observed at a point along the toe of the downstream slope, within the measuring pool. See Photos E-9

and E-10, Appendix II. No subsidence or movement of the rock fill slope immediately above the seepage area was observed.

PHOTO E-10: View of seepage pool and outlet channel. Note seepage at downstream toe.

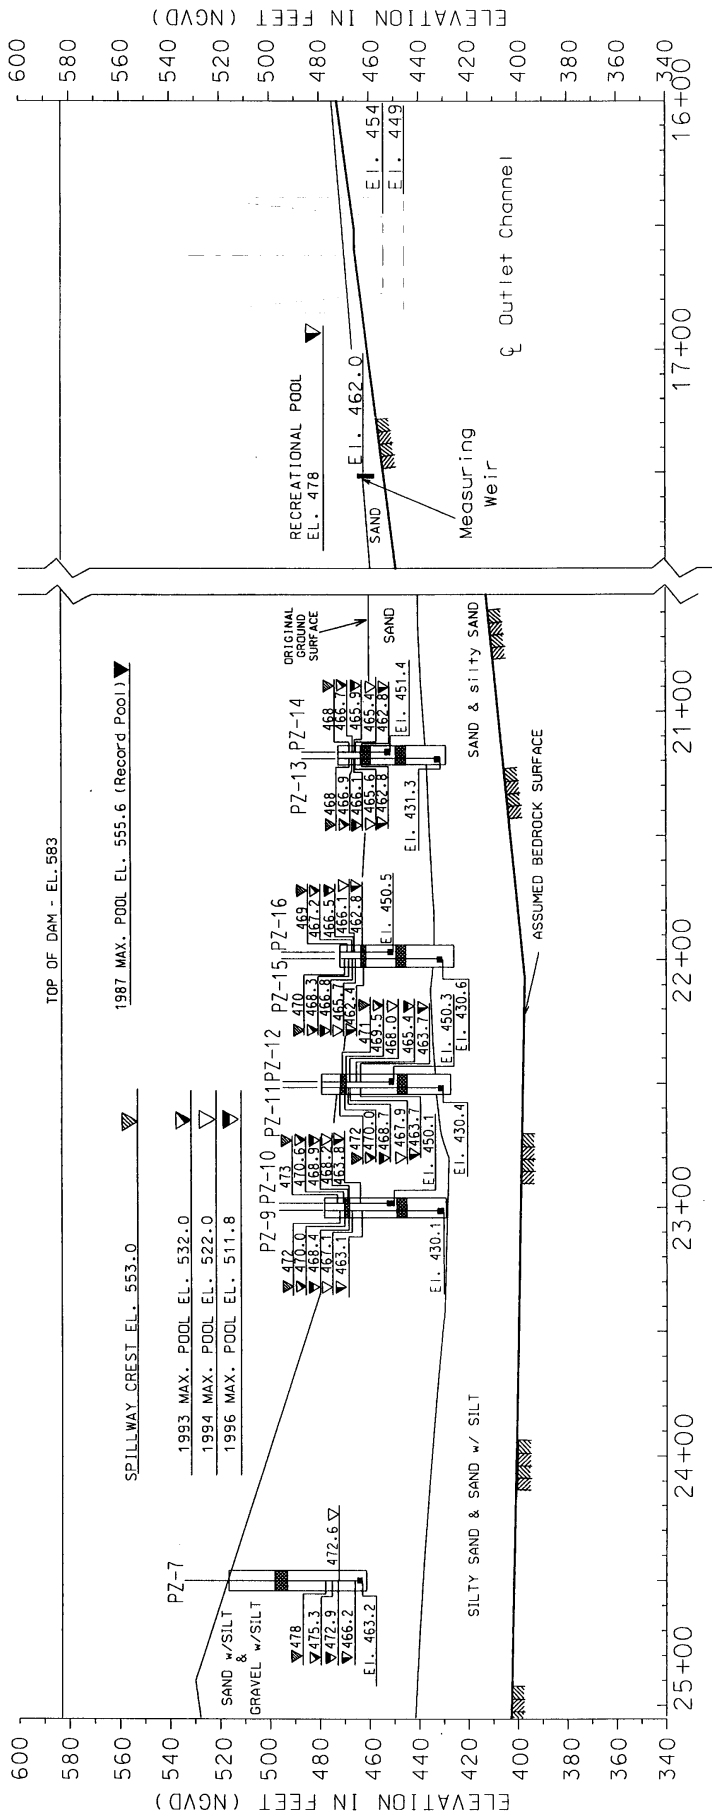
PROFILE C-C 250 FT DOWNSTREAM OF C OF DAM

the downstream toe of the dam, 250 ft downstream of the dam centerline (Plate 18). Four events were plotted on this profile: the 1987 flood event (maximum surcharge), the 1993 flood event, the 1994 event (Plate 25), and the 1996 event (Plate 26). Piezometer elevations for normal pool and for the pool at spillway crest were also plotted on this profile. Time history plots of pool and piezometer response for February 1994 through January 1997 were also prepared (Plates 19-24).
